PROPERTY CONDITION REPORT

T & P Tavern

221 West Lancaster Avenue Suite 1000
Fort Worth, Texas 76102

August 28, 2024

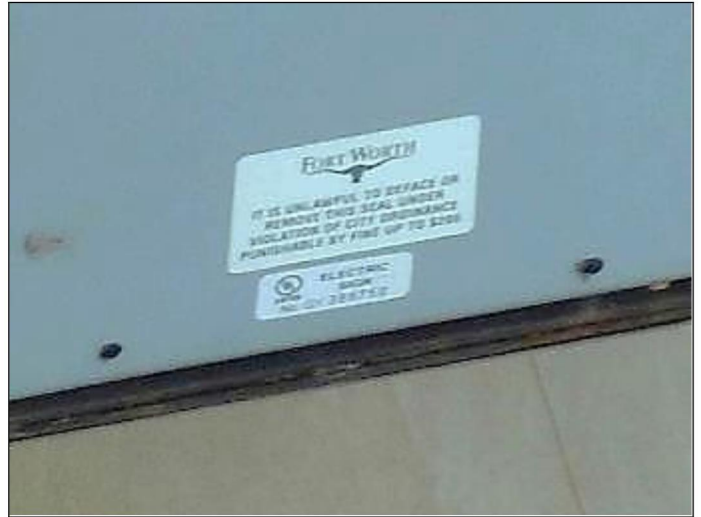
2. Signage permit affixed to sign

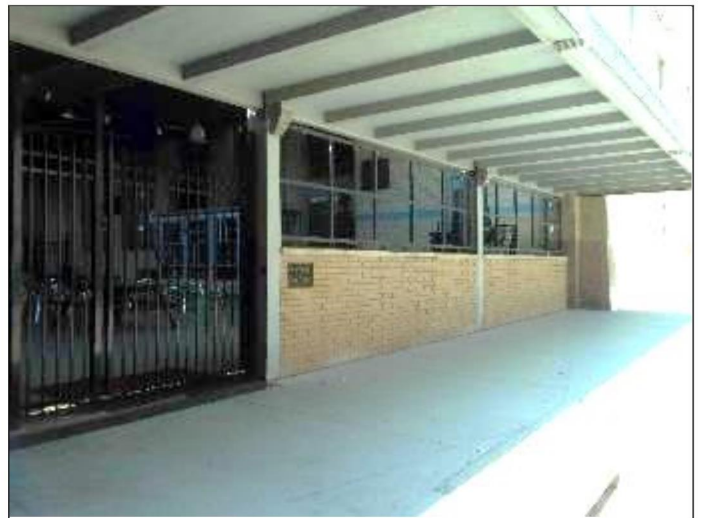
4. East façade and canopy at the south exterior patio area

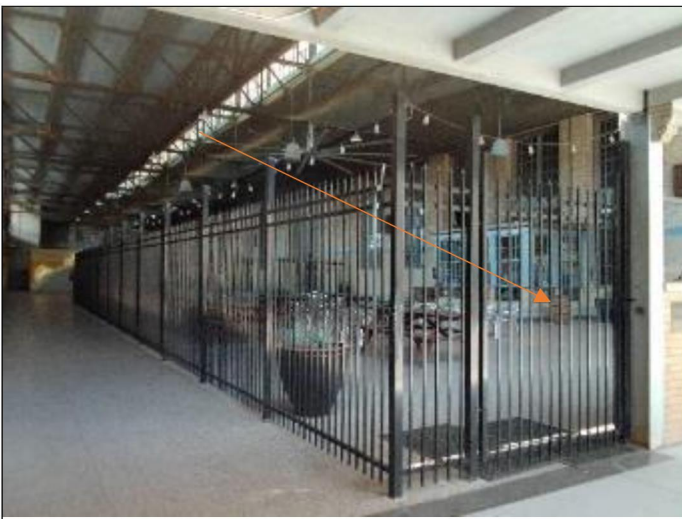
5. South exterior patio area fencing and southeast patron access gate

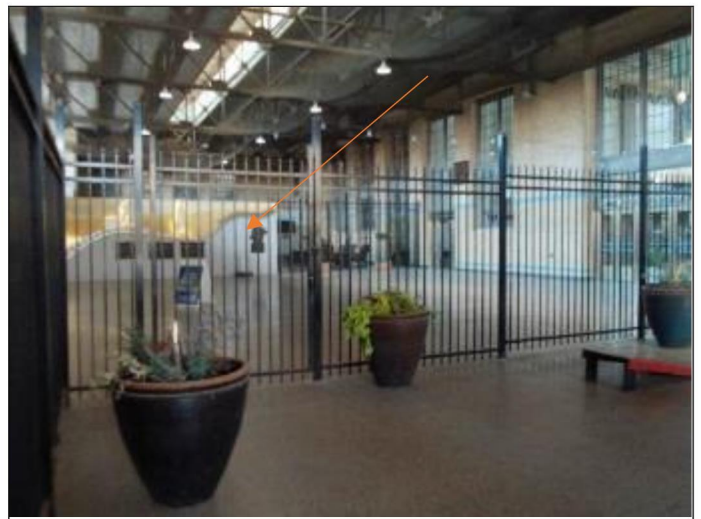
6. South exterior patio area fencing and southwest patron access gate

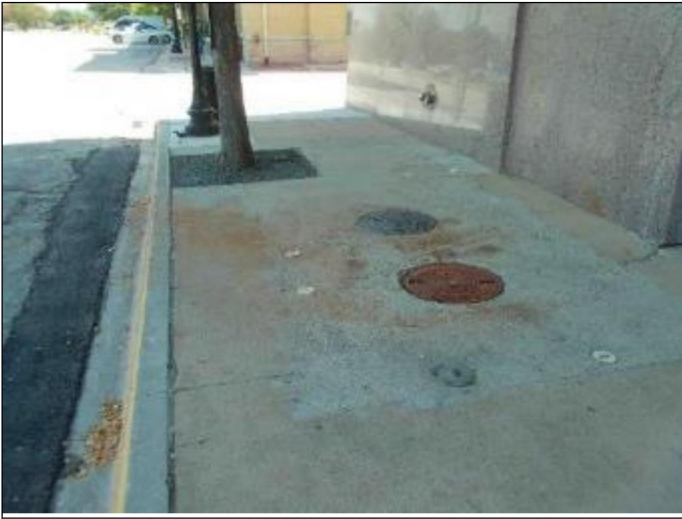
7. Location of the 1,000-gallon grease trap to remain at the northeast corner of the building

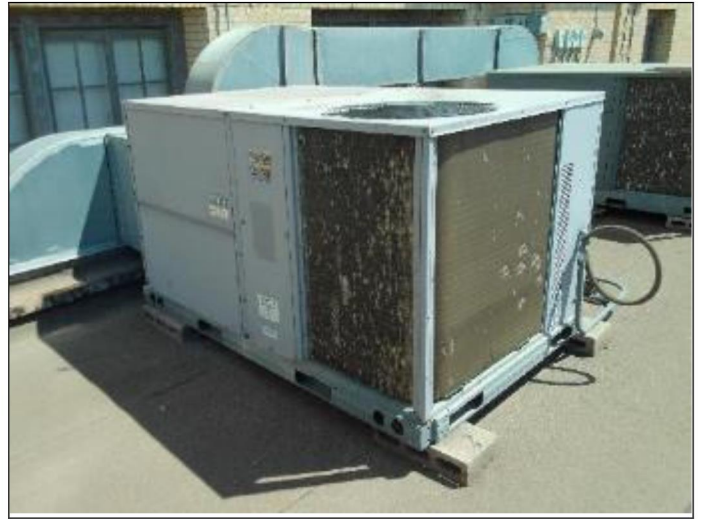
61. Goodman 2008 vintage 5-ton RTU on the open patio area roof that serves the dining/bar area; Note hail damaged coils

5.2	Replace packaged units- EUL reduced due to observed condition	17	14	3	14	14	TON	\$4,500			\$ 60,750										\$ 60,750	
6.0 Interior Elements

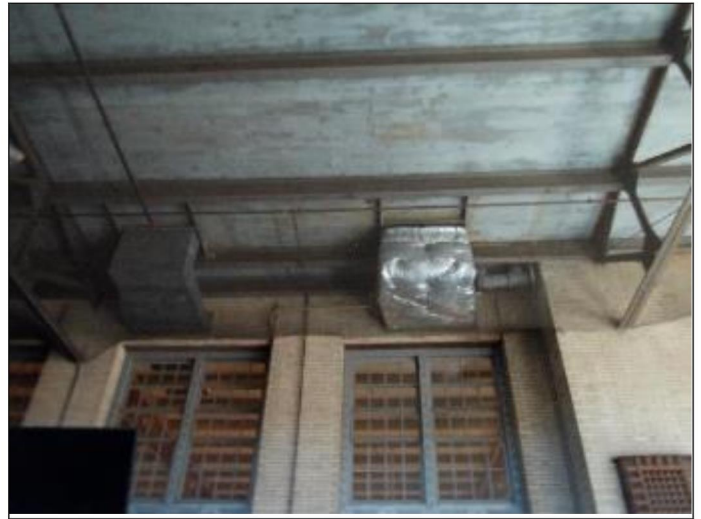
63. RTU ducting conditions

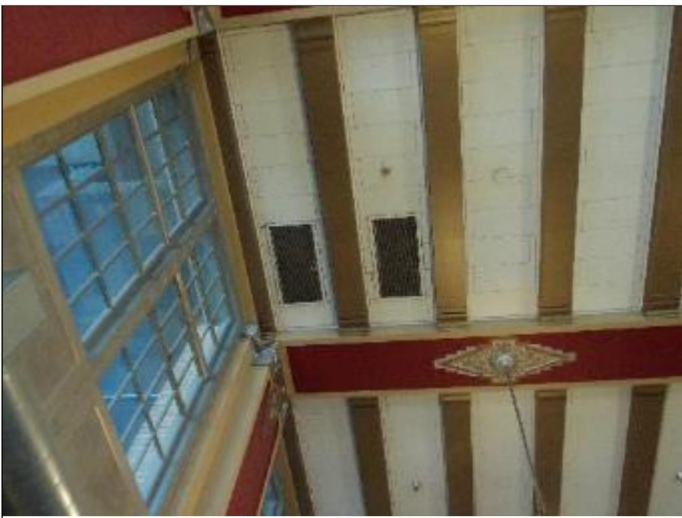
64. RTU ducting conditions

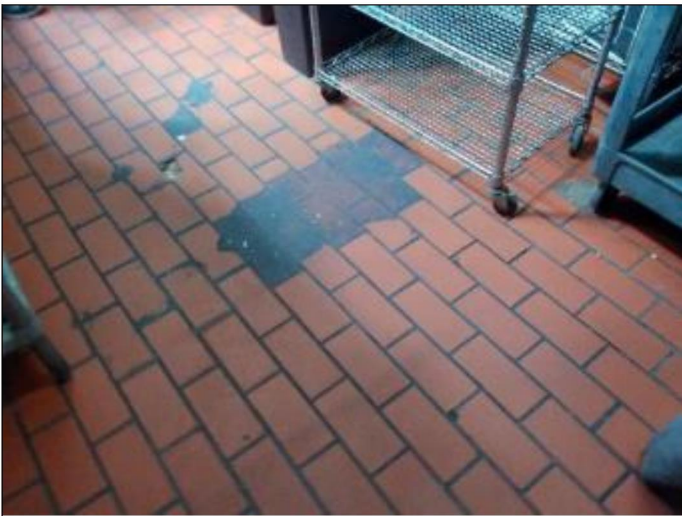
74. Kitchen area floor drains; Note flooring sealing repairs
