PROPERTY CONDITION REPORT

T & P Tavern

221 West Lancaster Avenue Suite 1000
Fort Worth, Texas 76102

August 28, 2024

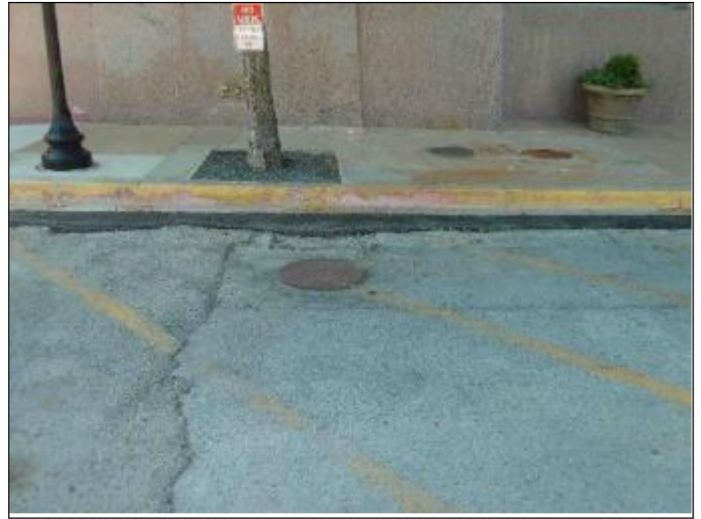
8. Location of the sub-grade sanitary sewer connection to the Municipal sewer system

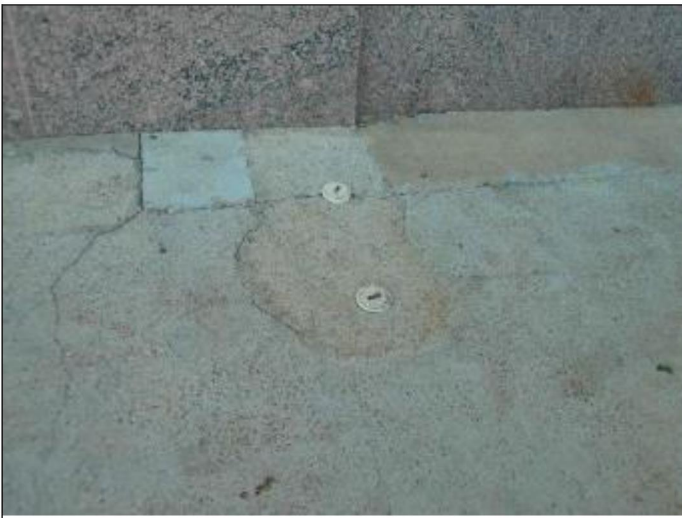
9. PVC sanitary cleanouts for the building sewer system

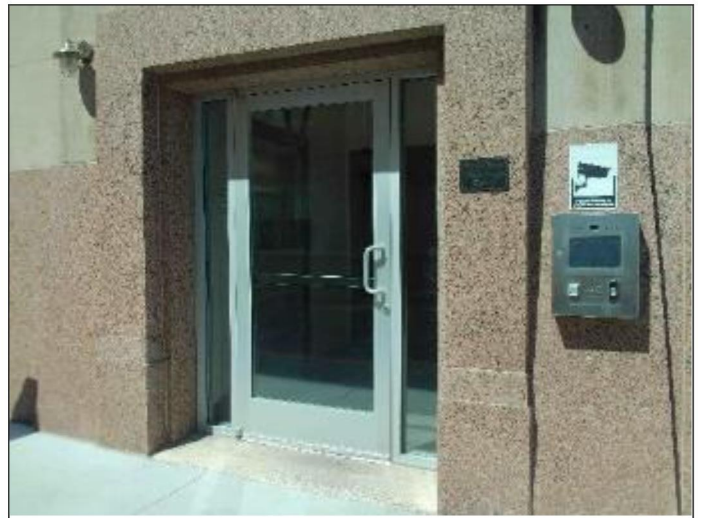
10. Northeast common building entrance leading to the kitchen access door and basement stairs

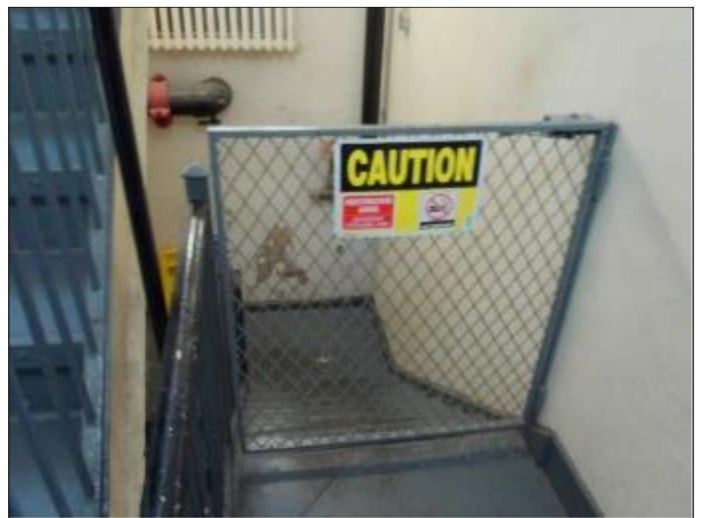
12. Basement access stairs and gate

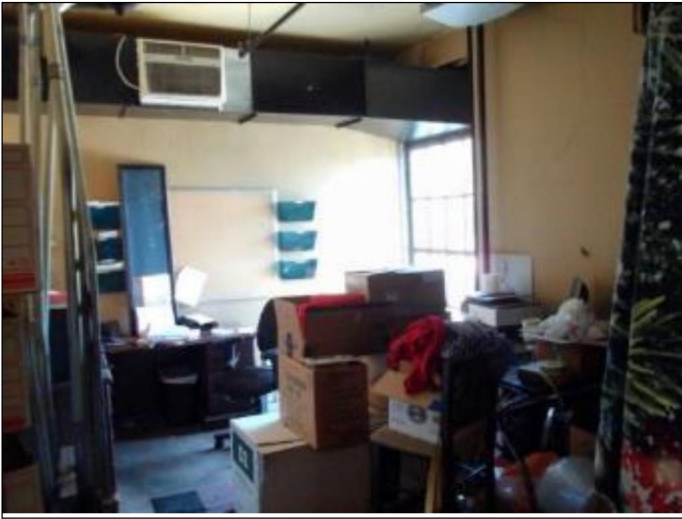
13. Second-floor rented office/common area space to be vacated by the current tenant

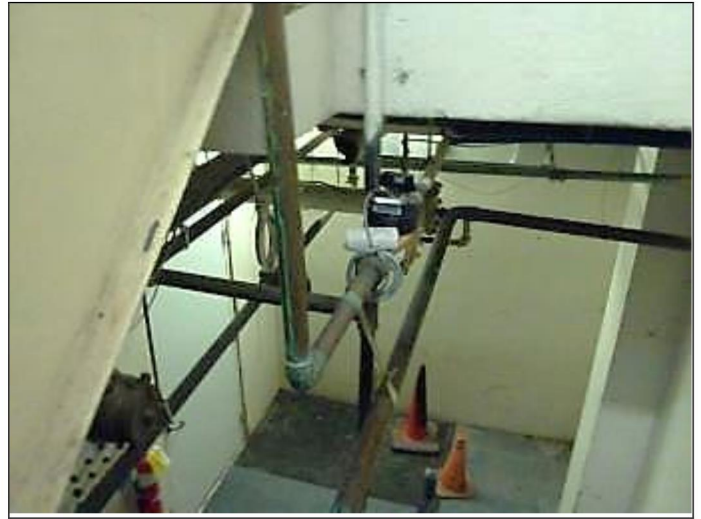
14. Main domestic water supply line and meter in the basement

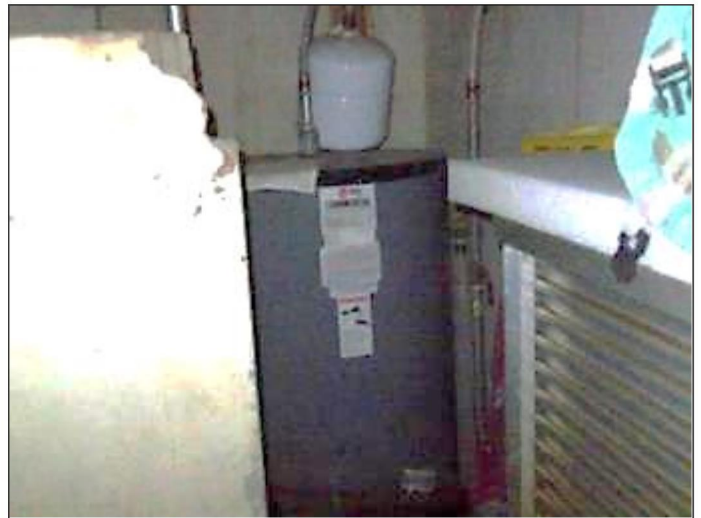
16. 120-gallon electric water heater to remain in the basement

5.0 Mechanical and Electrical Systems																						
5.1	Central Water heater (120 gal); and point-of-use water heater - Replace	10	9	1	1	2	ALLOV	\$7,000	\$ 7,000										\$ 7,000		\$ 14,000

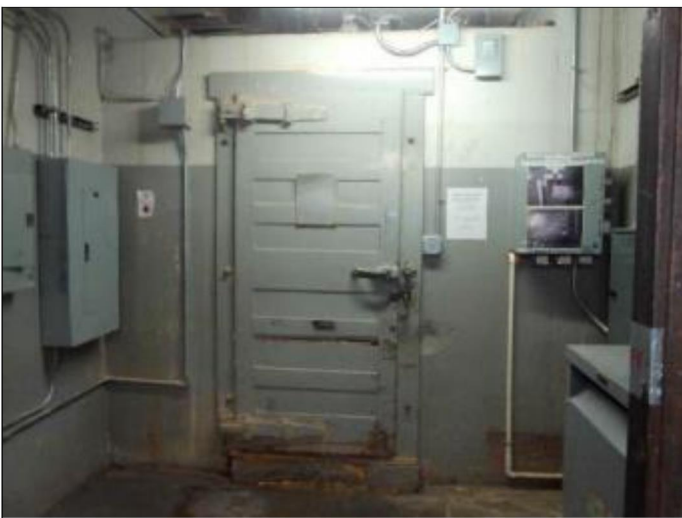
17. Beer walk-in cooler to remain in the basement

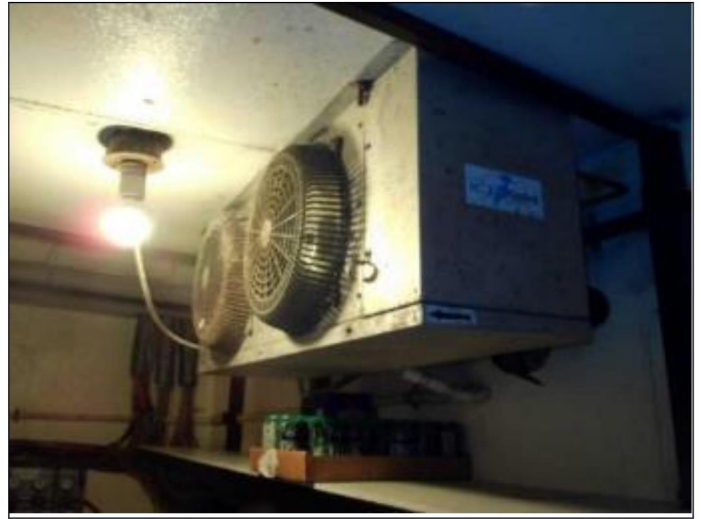
20. Beer cooler refrigeration unit to remain in the basement

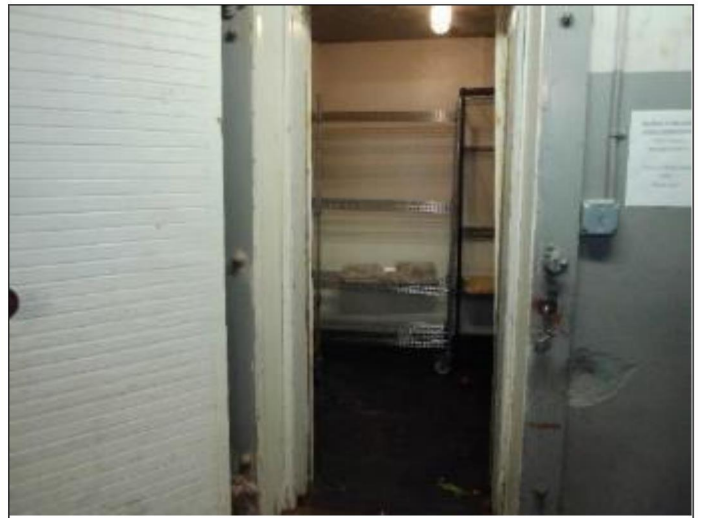
22. Food walk-in cooler to remain in the basement

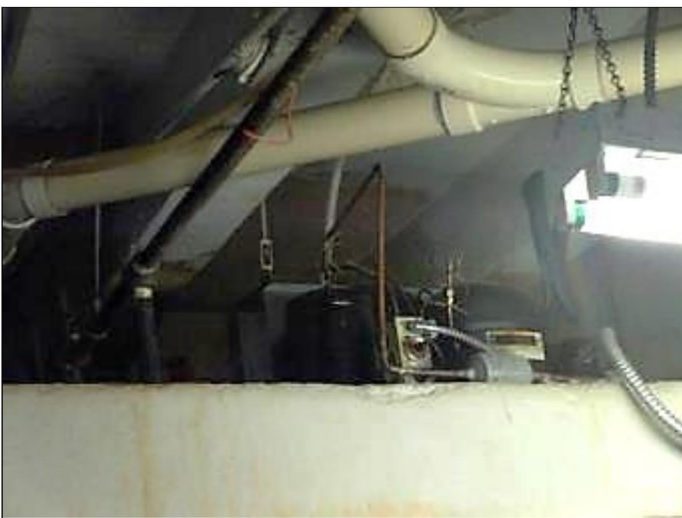
23. Food cooler 0.75-HP refrigeration compressor to remain in the basement

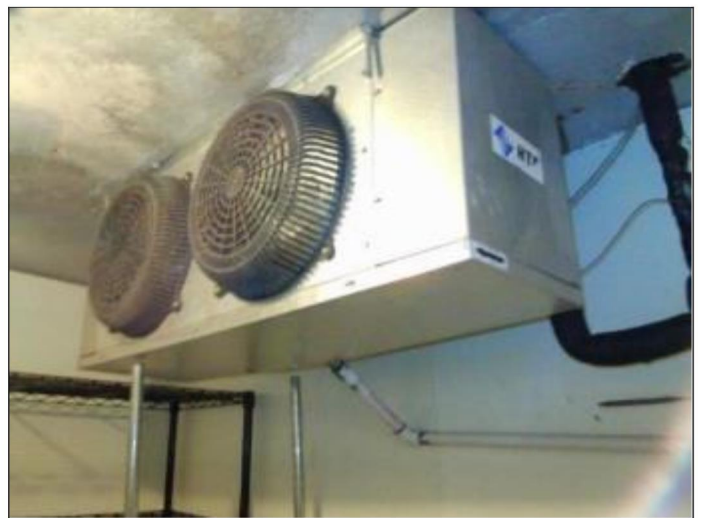
24. Food cooler refrigeration unit to remain in the basement

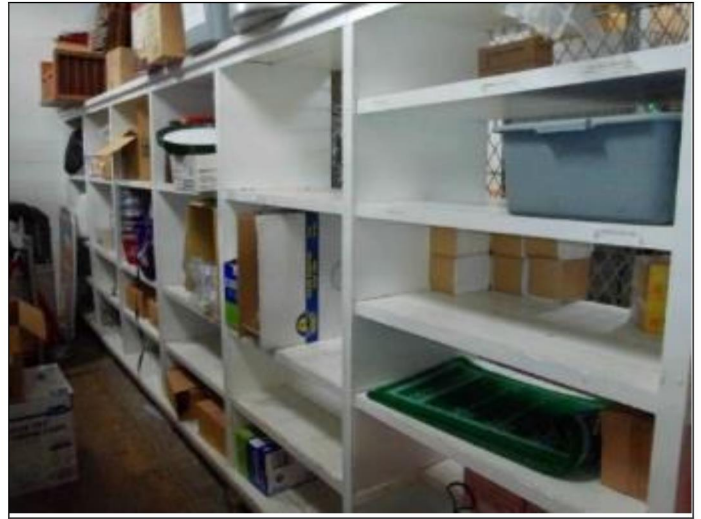
26. Typical dry storage area shelving to remain in the basement

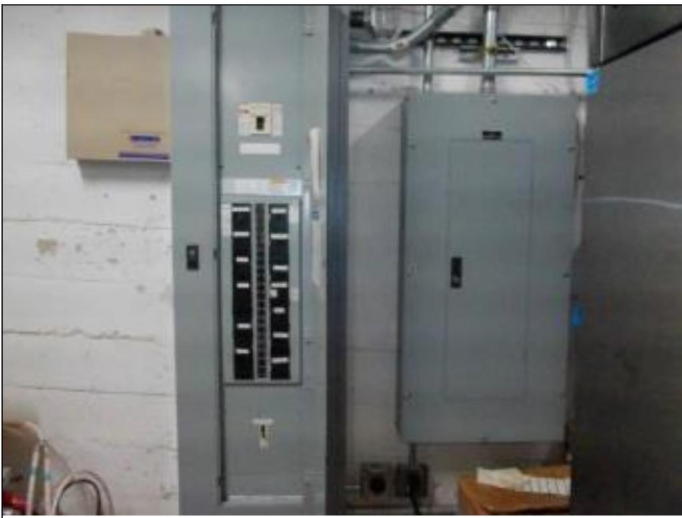
27. Subject property electrical panels in the basement

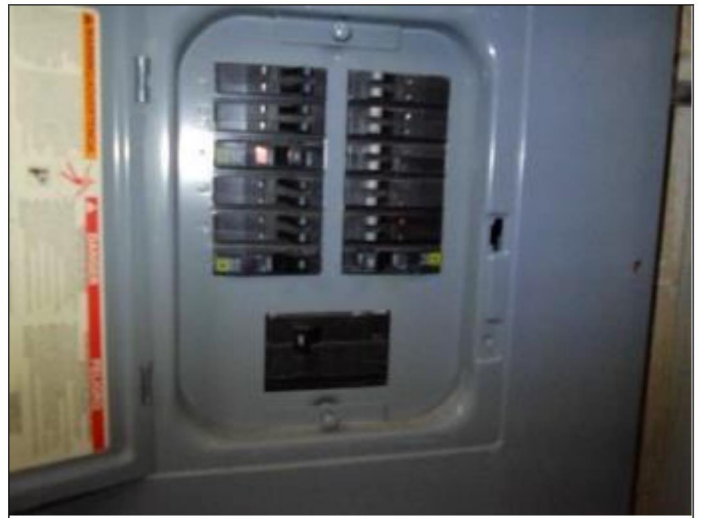
28. Subject property electrical panels in the basement

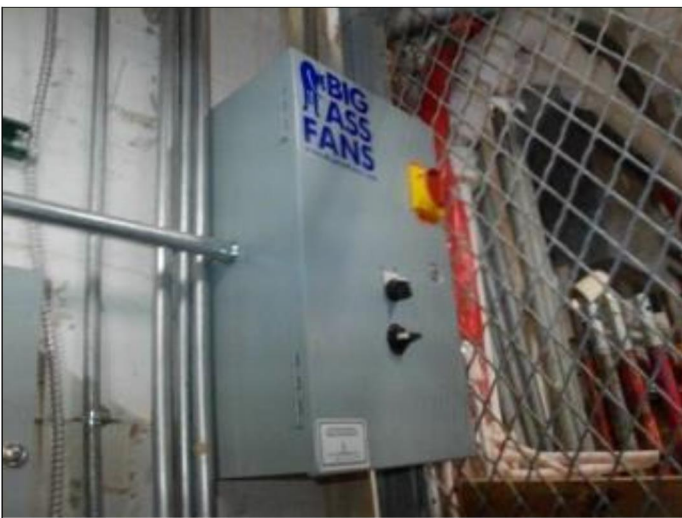
29. Subject property 'Big Ass Fan' electrical control panel to remain in the basement

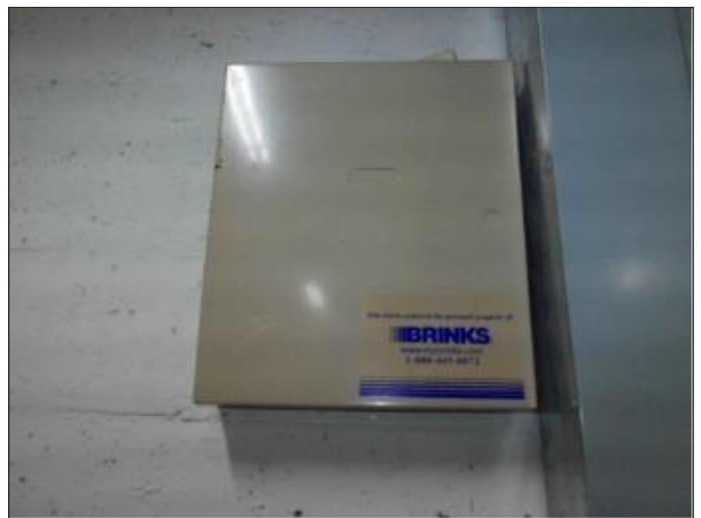
30. Subject property Brinks security system electrical control panel to remain in the basement

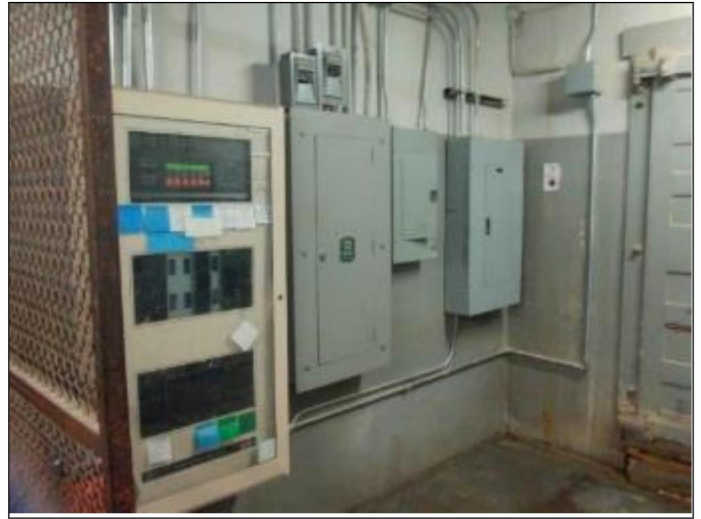
32. Main HOA owned FACP and HOA owned electrical panels in the basement

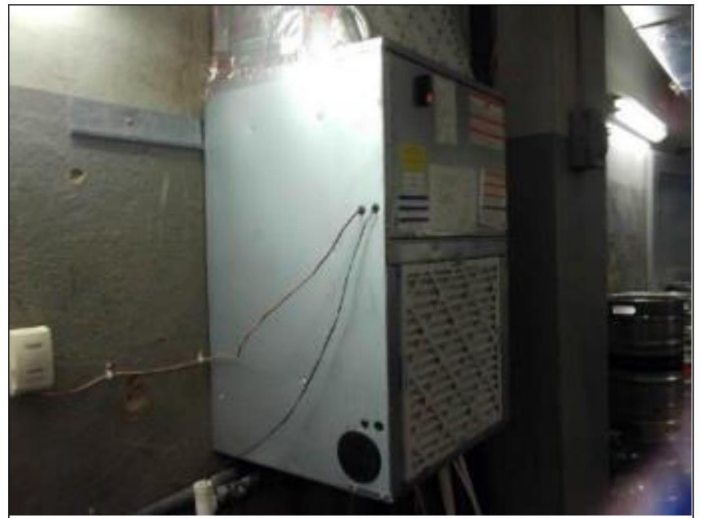
34. Split system HVAC condensing unit in the basement (HOA owned)

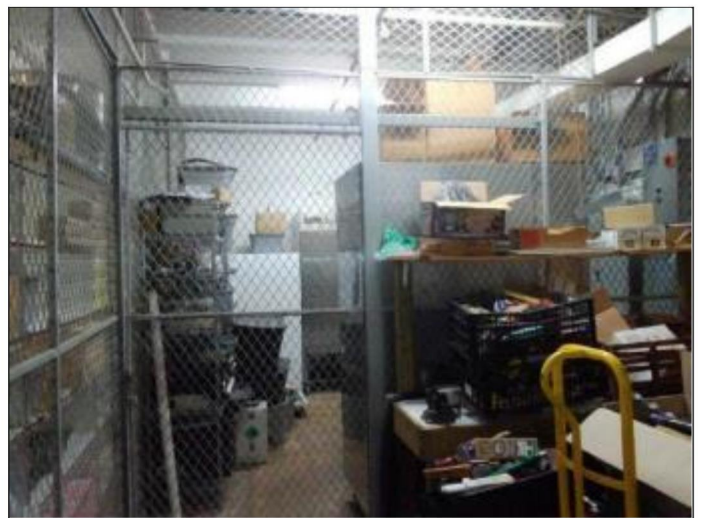
36. Gated locker to remain in the basement

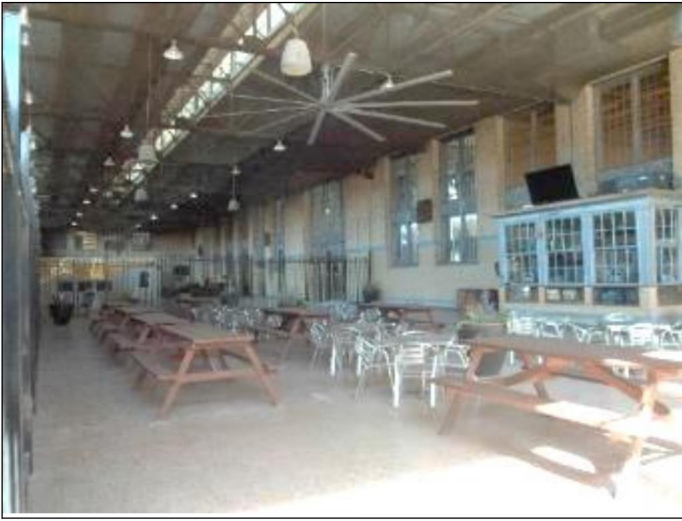
37. Overview of the south exterior patio area; Note current tenant-owned tables and chairs to be removed by the outgoing tenant

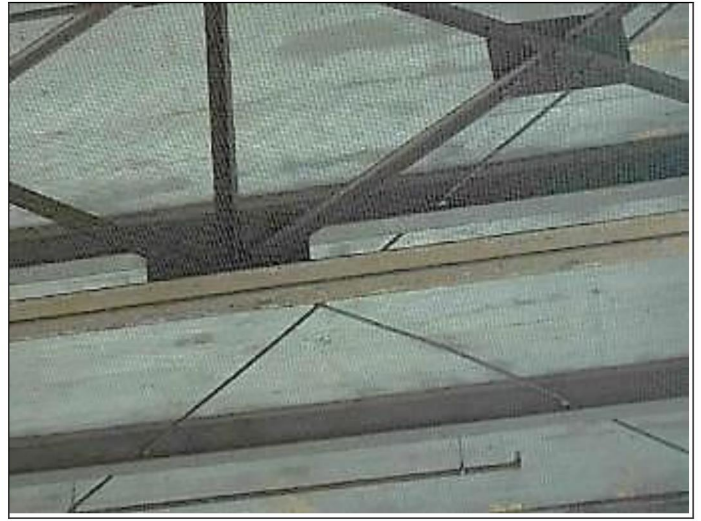
38. South exterior patio area bird netting on the exposed roof structure to remain

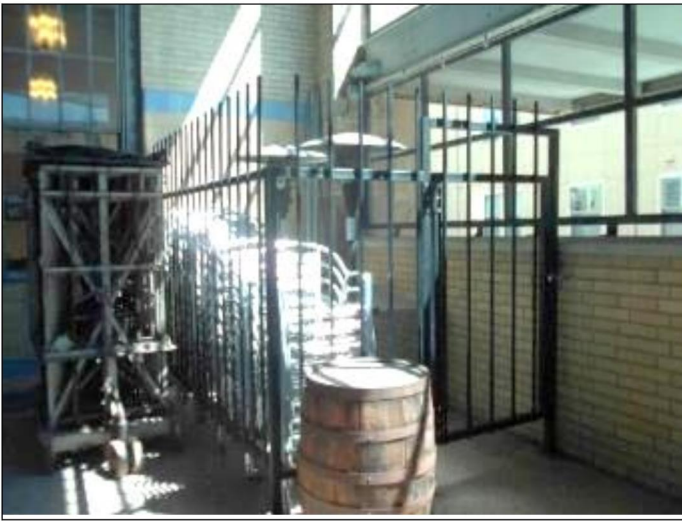
39. South exterior patio area storage cage structure to remain

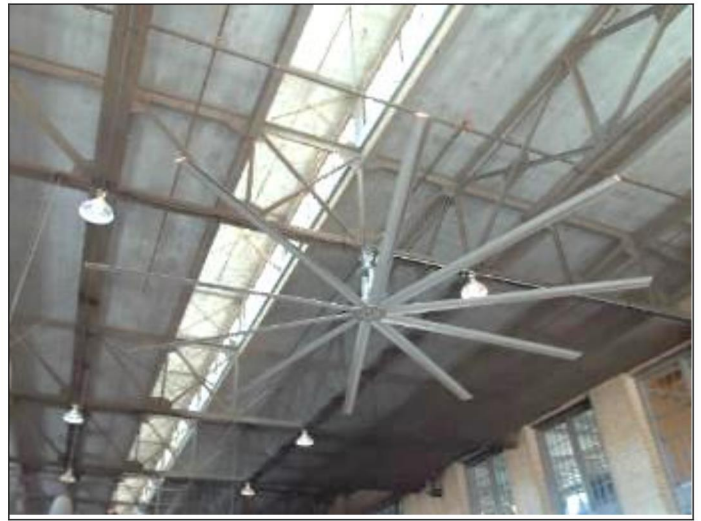
40. South exterior patio area 'Big Ass Fan' unit to remain; Note all patio area lighting is LED

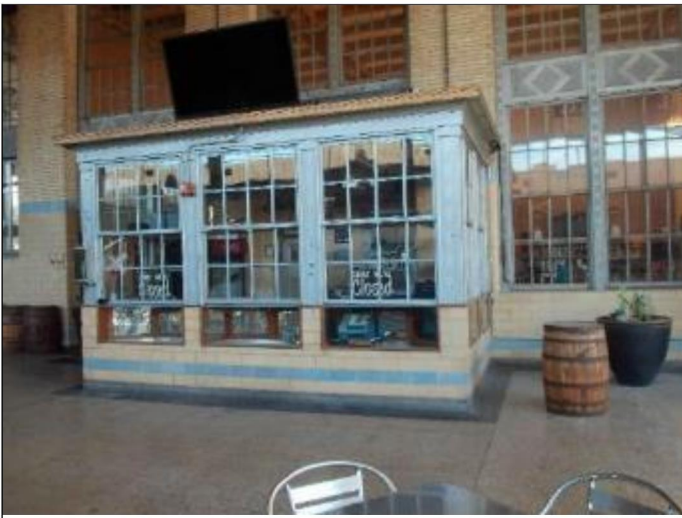
41. South exterior patio area service/bar kiosk to remain

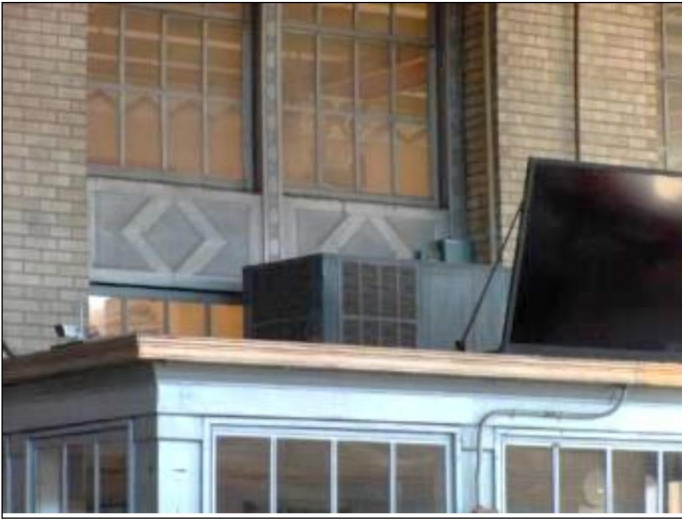
43. 2.5-ton packaged HVAC unit serving the service/bar kiosk and interior dining/bar area to remain

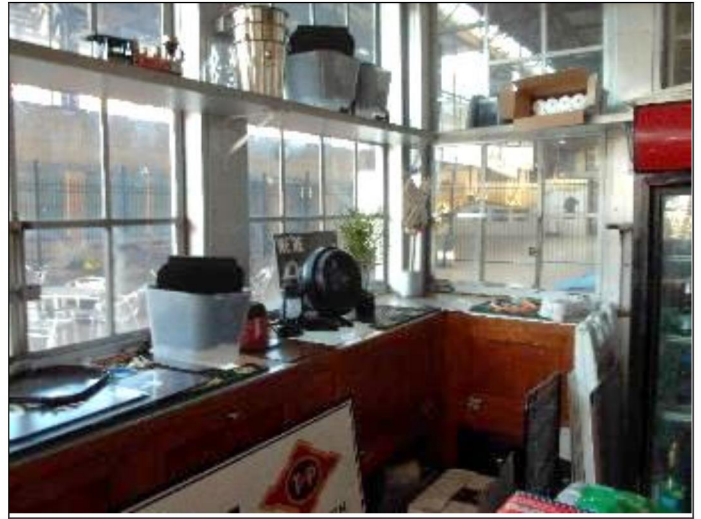
44. Service/bar kiosk shelving and cabinetry to remain

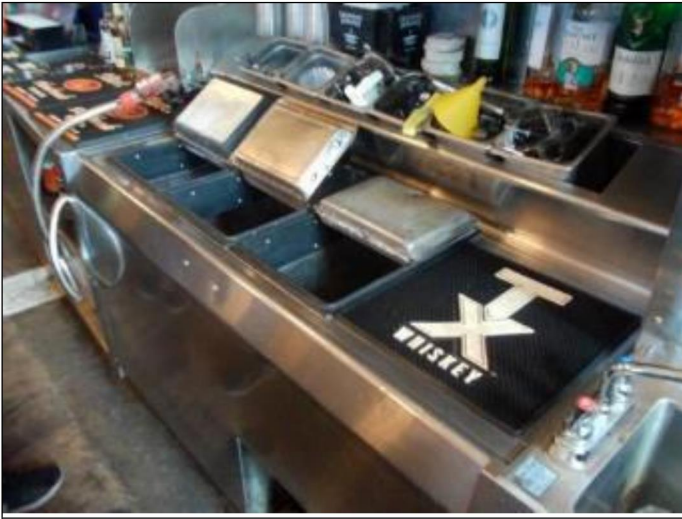
49. Interior bar area; Stainless steel ice cream cooler to remain

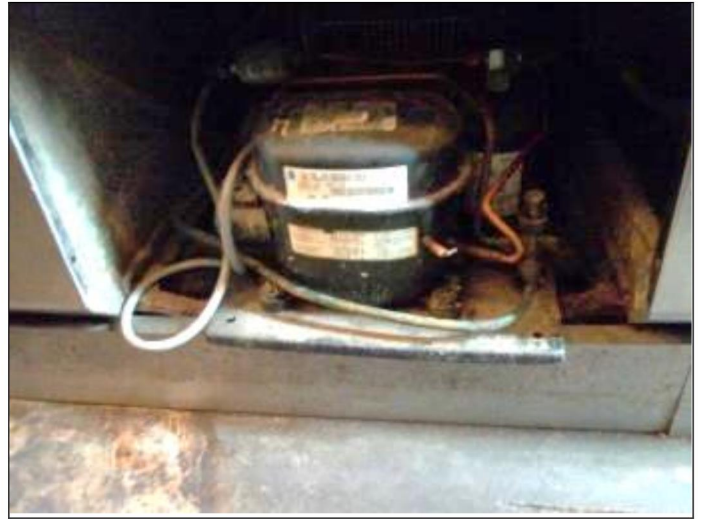
50. Interior bar area; Stainless steel ice cream cooler refrigeration unit to remain

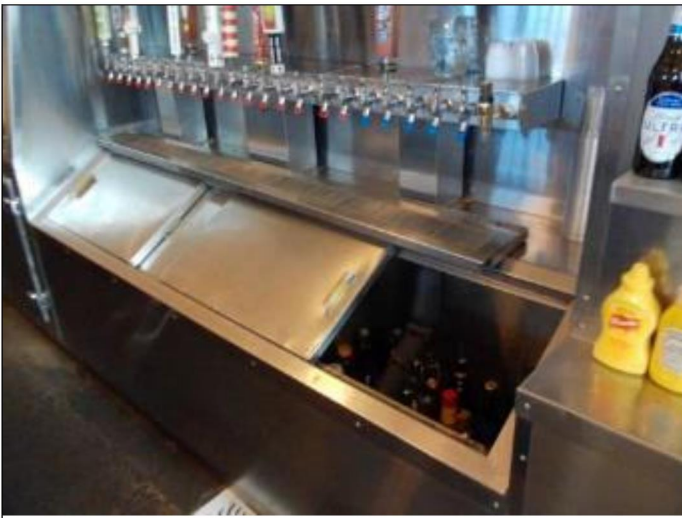
51. Interior bar area; Stainless steel beer cooler to remain

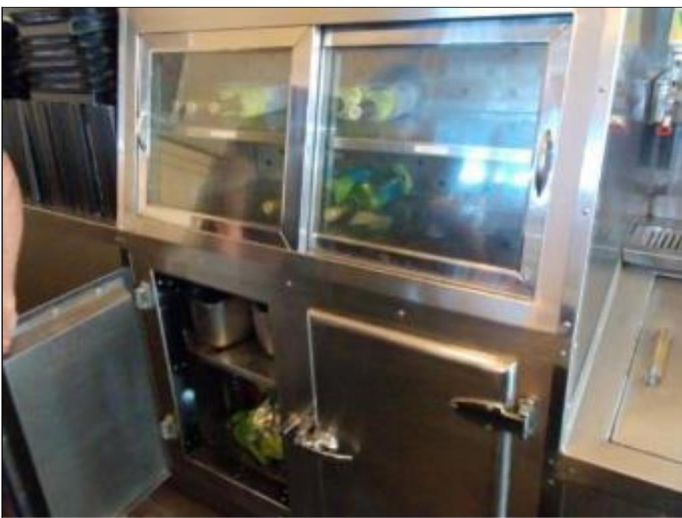
53. Interior bar area; Stainless steel wine cooler to remain

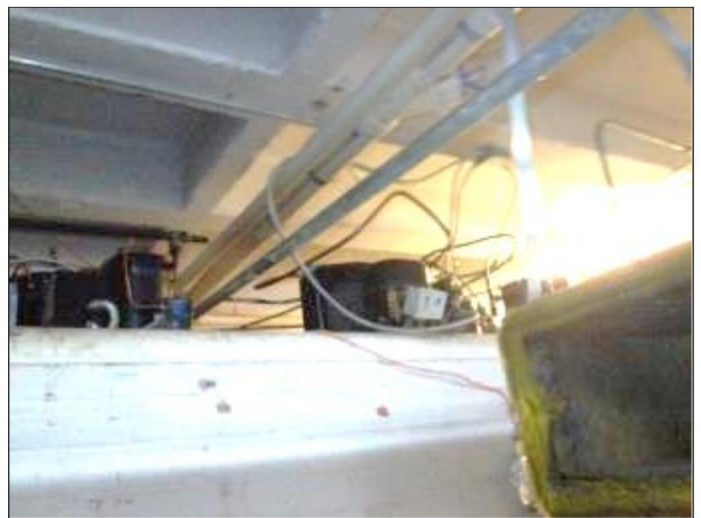
54. The refrigeration compressor unit for the bar area wine cooler is located in the basement

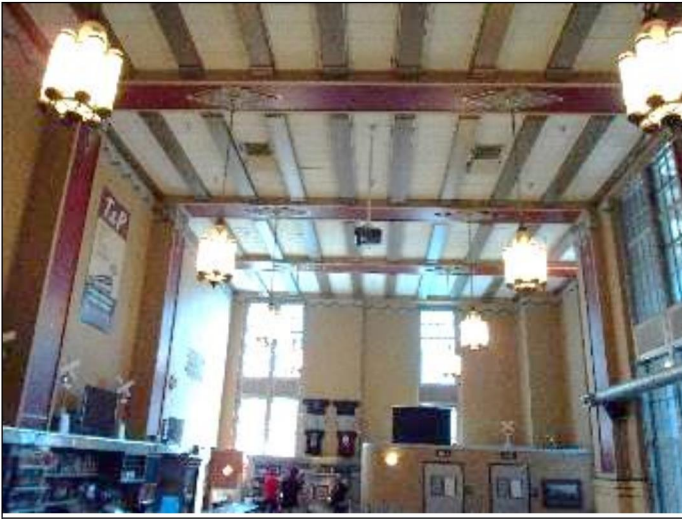
55. Dining/bar area chandeliers (8) to remain; Note chandeliers have LED bulbs

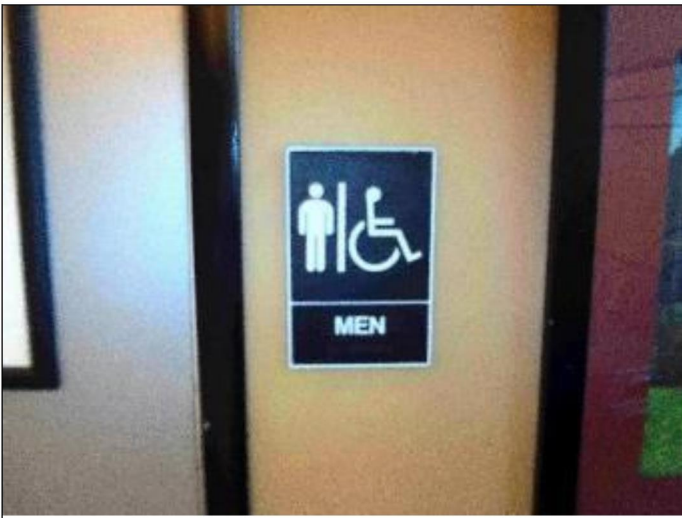
57. The restroom signage is missing compliant signage (Braille lettering is missing)

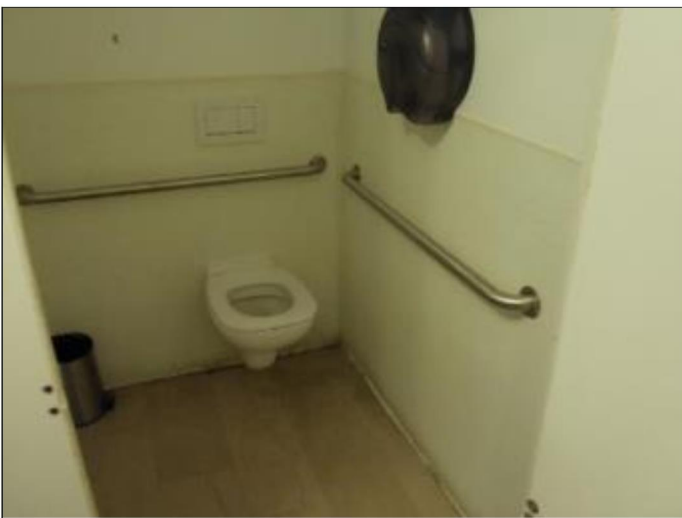
59. The toilet paper dispensers are not installed at compliant heights in both restrooms

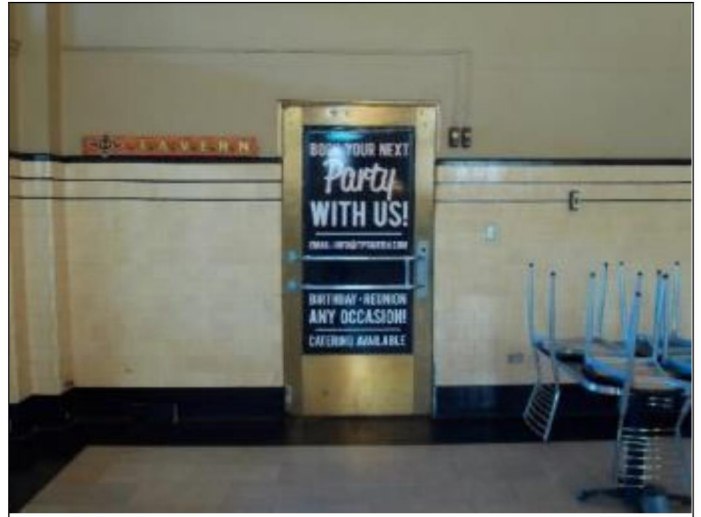
68. Dining/bar area locked access door leading to the west adjoining TRE Function Hall

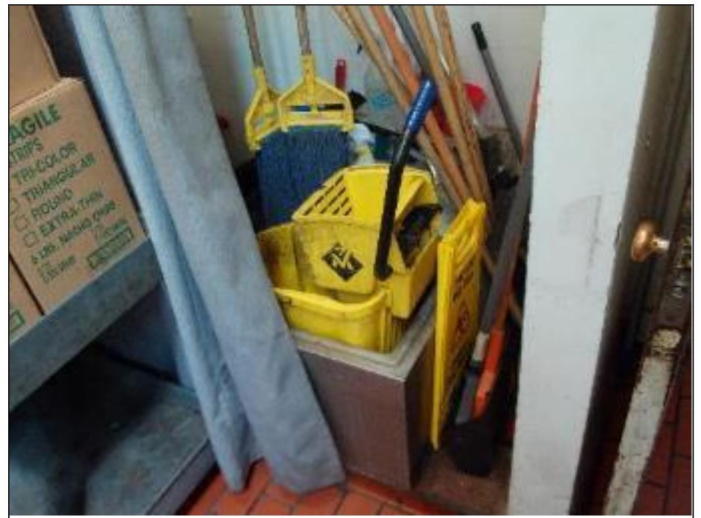
70. Janitorial closet with mop sink in the kitchen area

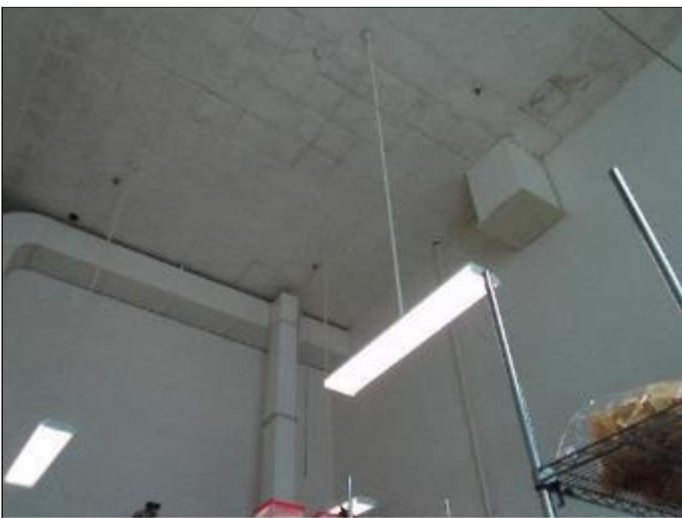
71. Kitchen ceiling finishes and suspended LED lighting fixtures

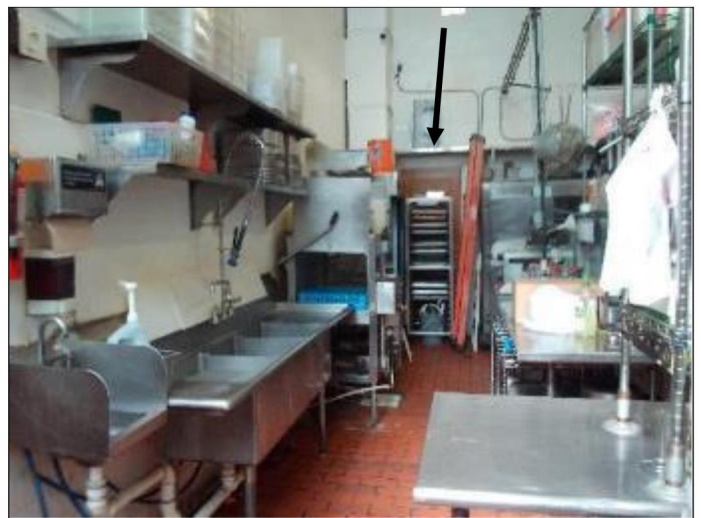
72. Overview of the kitchen area; Note the locked access door leading to the west adjoining TRE meeting room

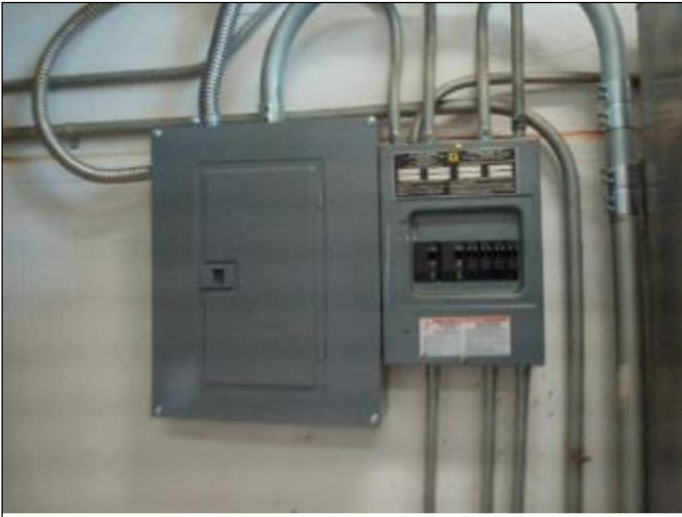
73. Kitchen area electrical panels

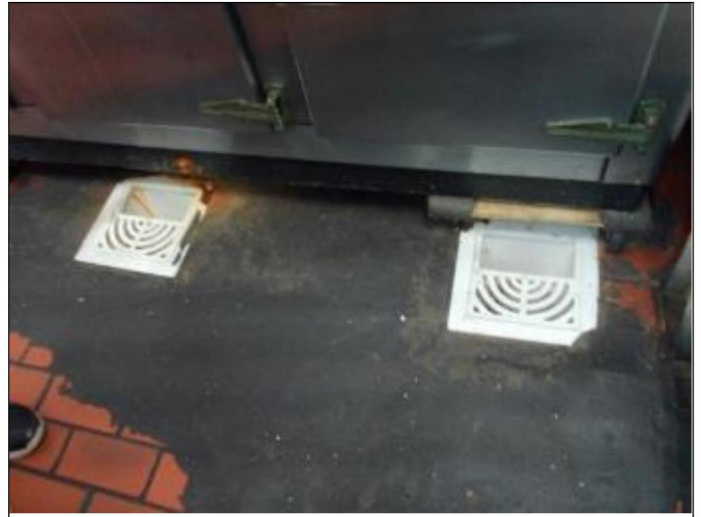
74. Kitchen area floor drains; Note flooring sealing repairs

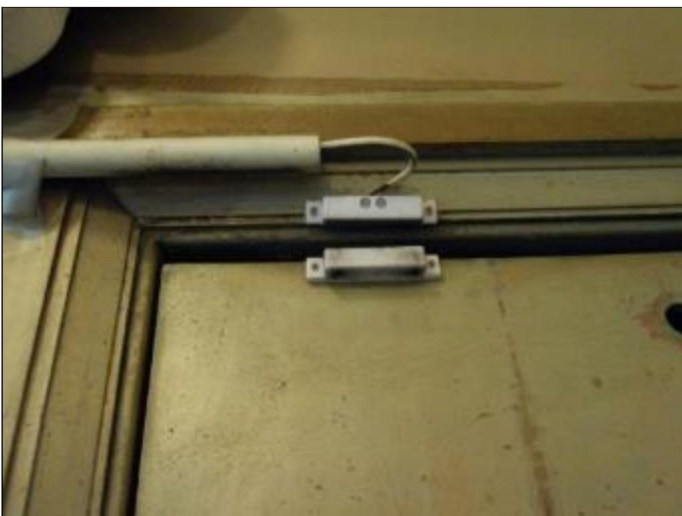
77. Typical security system door sensor

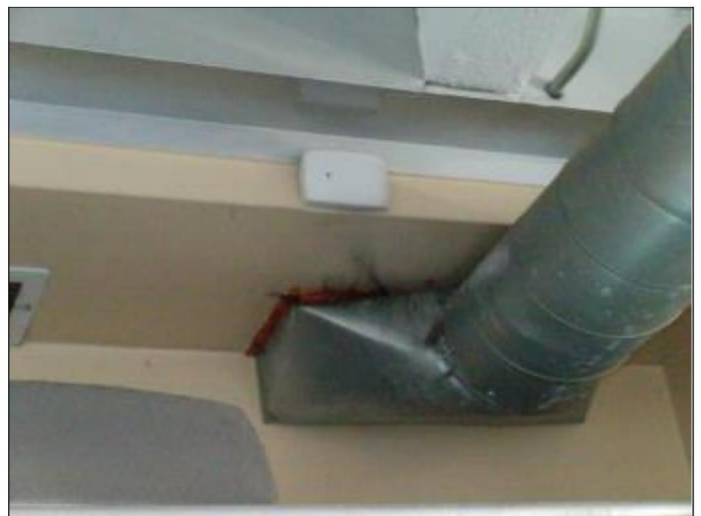
78. Typical security system kiosk sonic glass break sensor

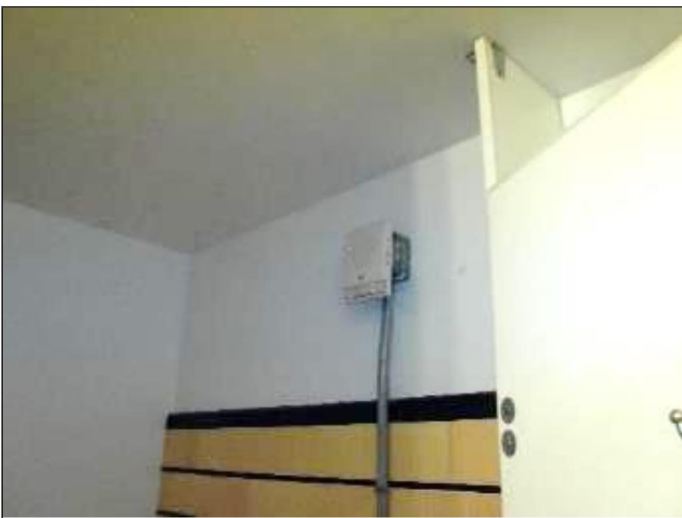
83. Only the women's restroom was provided with a fire alarm system audible/strobe unit
