PROPERTY CONDITION REPORT

T & P Tavern

221 West Lancaster Avenue Suite 1000
Fort Worth, Texas 76102

August 28, 2024

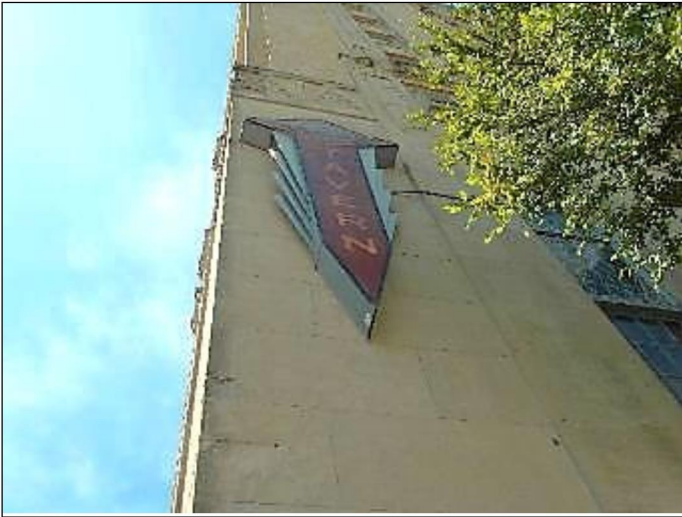
1. Property signage to remain

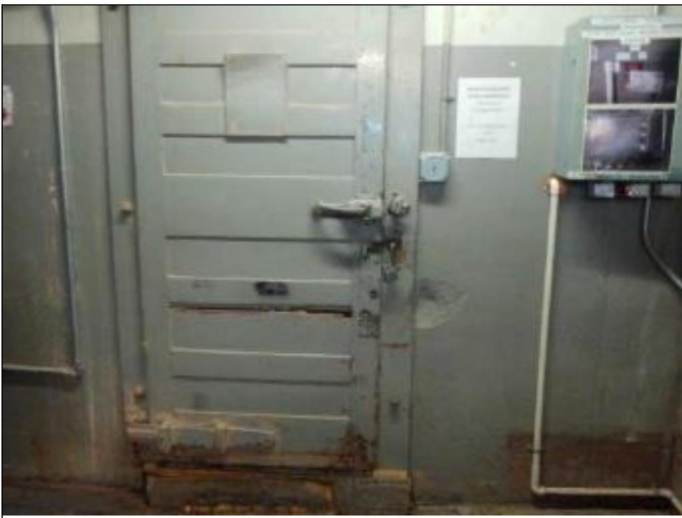
21. Food walk-in cooler to remain in the basement

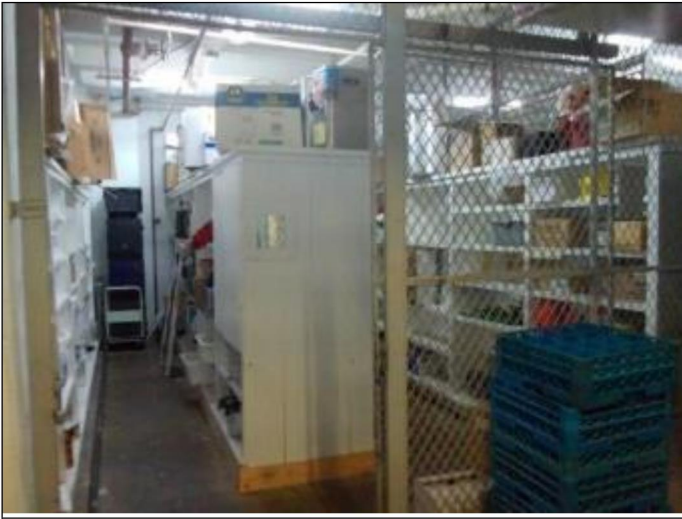
25. Dry storage area to remain in the basement

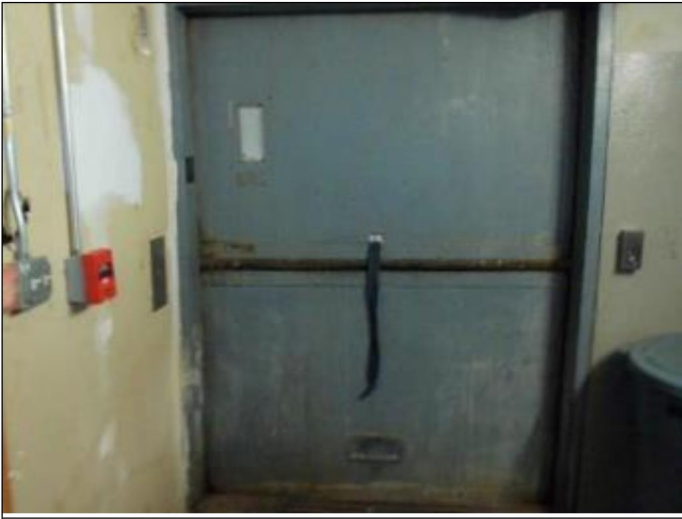
31. Freight elevator access in the basement (HOA owned)

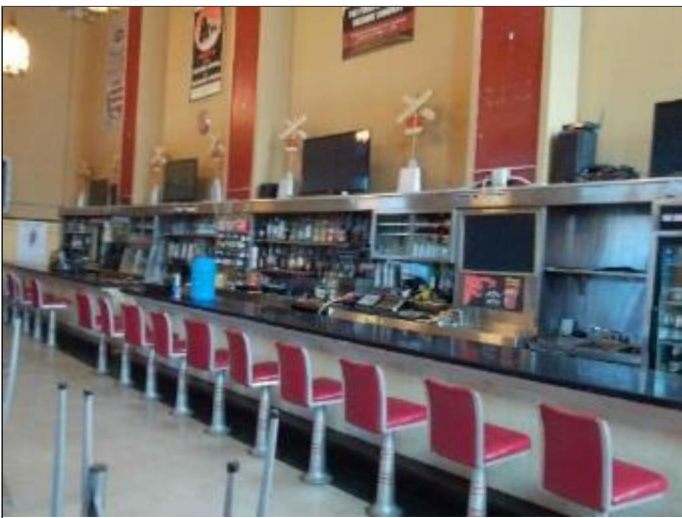
47. Interior bar area; Stainless steel bar backs and stools to remain

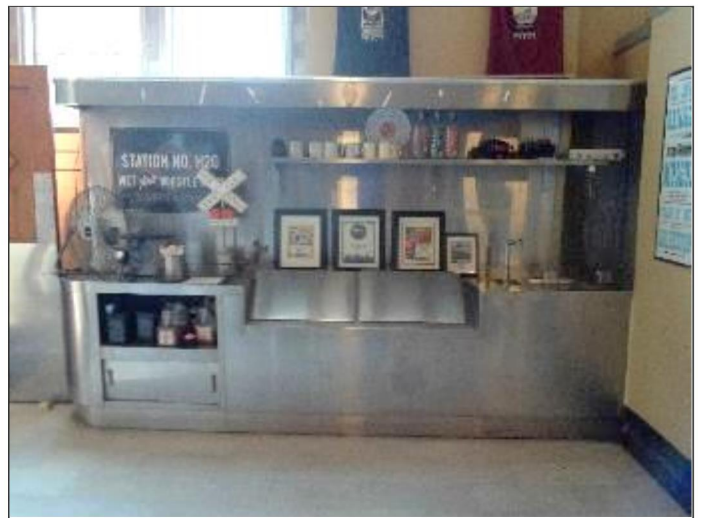
48. Interior bar area; Stainless steel bar back to remain

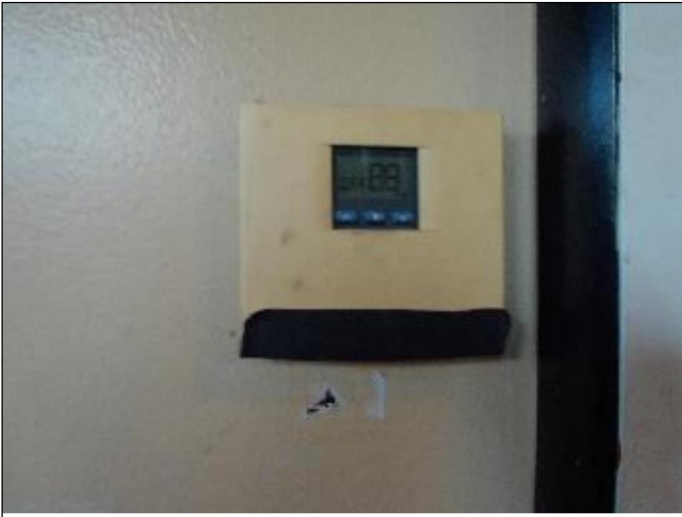
67. Typical thermostat

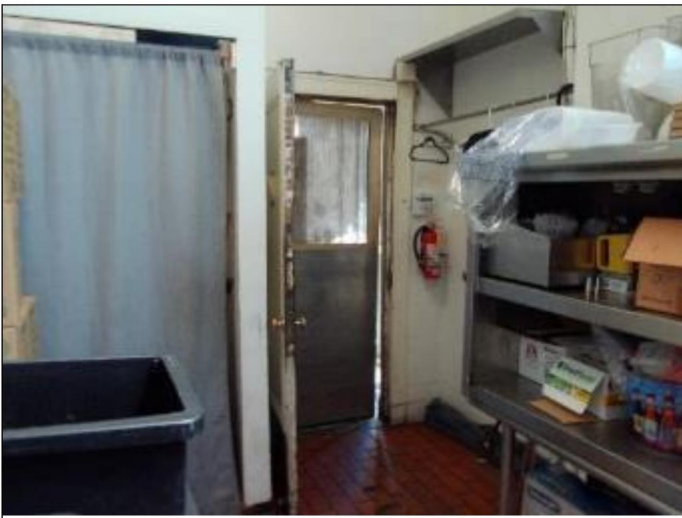
69. Kitchen/employee entrance at the northeast corner of the subject property
